LEVEL 2

Your survey report

17th November 2021

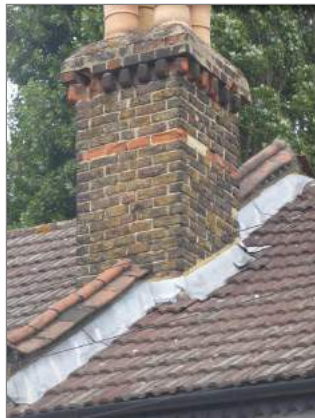
We noted worn brick joints to the first two chimney stacks and localised repointing will be required by a reputable roofer in the medium term (2-5 years). We also noted a few spalled brick faces which can be repaired in-situ at this time. Condition Rating 2.

Photo - 3 Front chimney stack- worn pointing

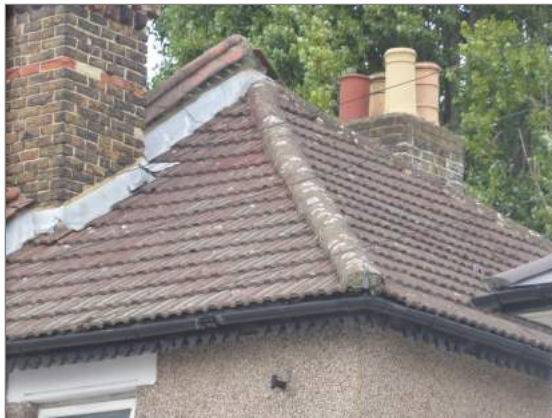
The observed roof covering appears in a serviceable state of repair, with no significant defects noted. Condition Rating 1.

Photo - 4 Main roof covering- fair order

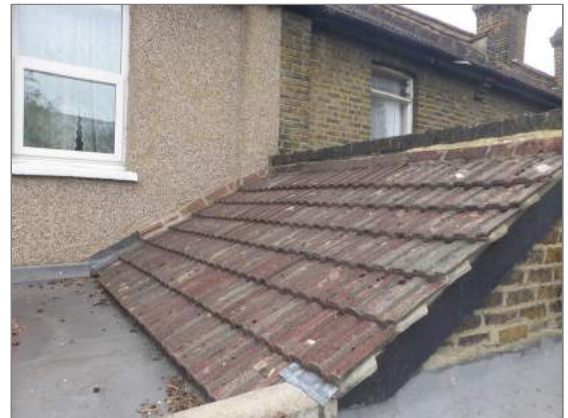
The roof to the original rear outrigger is pitched, covered with interlocking concrete tiles. The construction and condition is consistent with that of the main roof. Condition Rating 1.

Photo - 5 Rear outrigger- fair order but a number of different flashings have been used around its perimeter and these can sometimes be difficult to bond

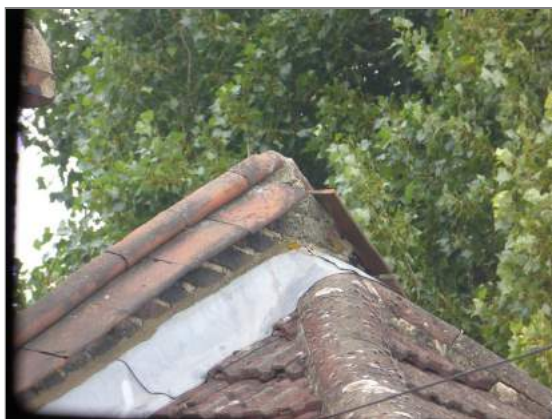
Parapet walls are located at roof level. These structures are particularly exposed to the weather and require regular maintenance to ensure stability and weather tightness. The copings near the ridge point of the main parapet wall are missing/damaged. Localised repair is required by a reputable roofer in the next 12 months. Condition Rating 2.

Photo - 6 Damage to parapet ridge copings

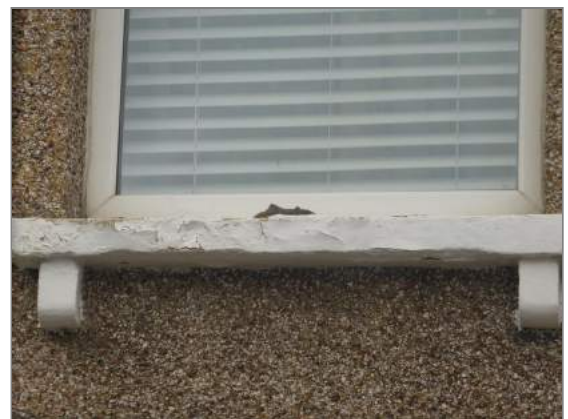
Fine cracking was noted to the rear first floor window ledge but the damage to the front first floor window ledge is more prominent and cracks require filling and painting over by a reputable general contractor. If this is not undertaken, rainwater may pass through the fine cracks into the wall below the window openings. Condition Rating 2.

Photo - 7 Front window ledge- fine cracking and flaking paint

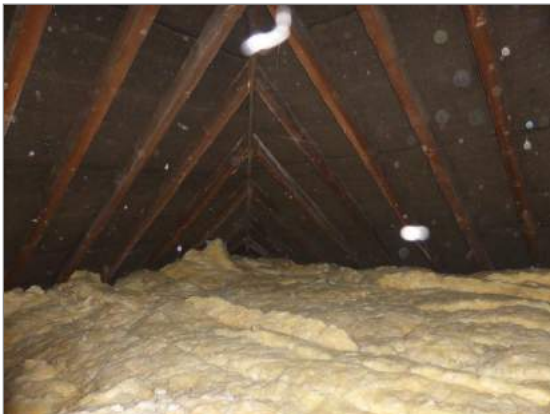
The visible areas of the roof frame are of traditional design for this type of building. There is no evidence of significant distortion although there is some slight deflection considered normal in a property of this age and type and to be within acceptable tolerances. Condition Rating 1.

Photo - 8 Main roof frame- fair order

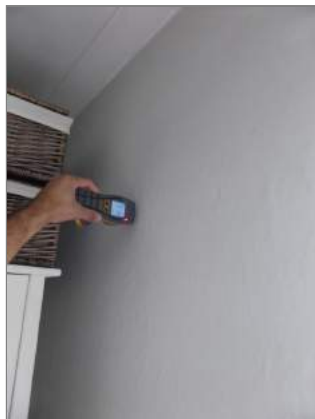
Systematic damp tests were made using electronic moisture meter and we noted above average readings to the section of external wall on the left-hand side of the first floor bedroom window. We believe this to relate to hygroscopic salt contamination from the chimney breast which has been removed in the past. Hygroscopic salts can contaminate plaster and brickwork, readily absorbing moisture from the air. Usually, localised replastering is required to mitigate the effects and this is likely to be needed here. Dampness is likely to be more prominent to this wall in colder months where there is more condensation (see Section I1). Condition Rating 3.

Photo - 9 Above average damp readings to rear bedroom external wall

High dampness was noted to an area of the rear bedroom external wall. It is highly likely replastering will be required with a salt inhibitor.

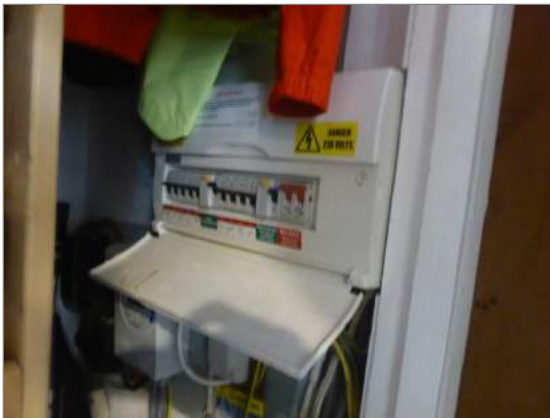
The observed wiring and fittings are of relatively modern style, nevertheless current guidelines advise electrical installations should be tested every 10 years or upon a change of ownership. This is to guard against DIY additions and alterations which may have been carried out since the last re-wiring/certification. We recommend a Periodic Inspection should now be carried out by a qualified electrician if certification is not available and any deficiencies ascertained should be rectified (see Section I3). Condition Rating 3.

Photo - 16 Modern consumer unit

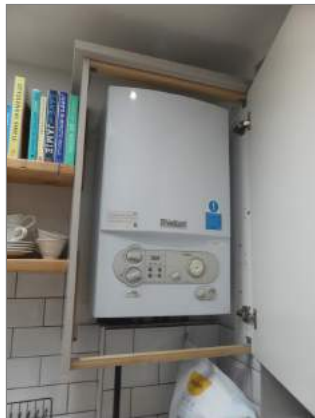
Boilers of this type should be serviced annually by a registered engineer. Specific enquiries should be made through your legal advisor as to the service history of the installation and, if this is not supported by documented evidence, then it is recommended the installation is inspected by a registered engineer prior to legal commitment to purchase (see Sections H2 and I3). Condition Rating 3.

Photo - 17 Mid range combination boiler
