LEVEL 3

Your survey report

12th April 2022

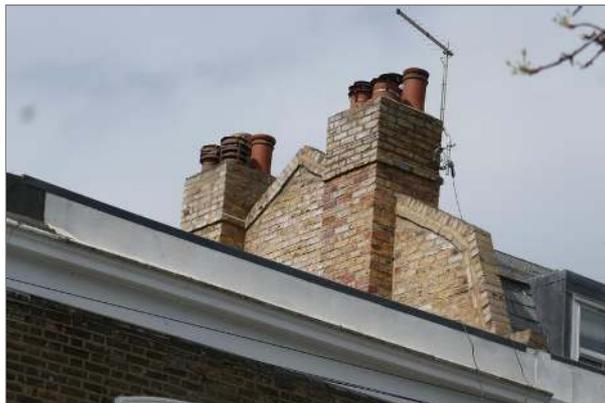
The chimneys appeared in reasonable condition, with only some minor weathering noted. Condition Rating 1.

Photo - 2 The chimneys in fair order.

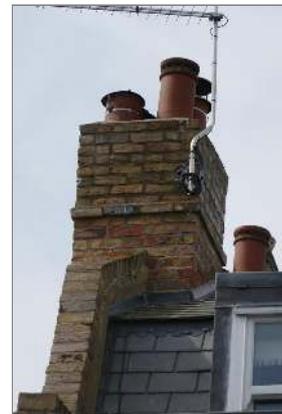
Photo - 3 Front chimney showing leadwork at base; all in fair order.

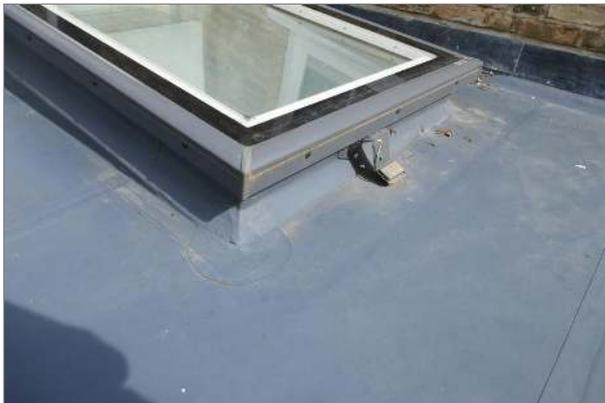
Photo - 4 Adequate, well-sealed detail around kitchen roof light.

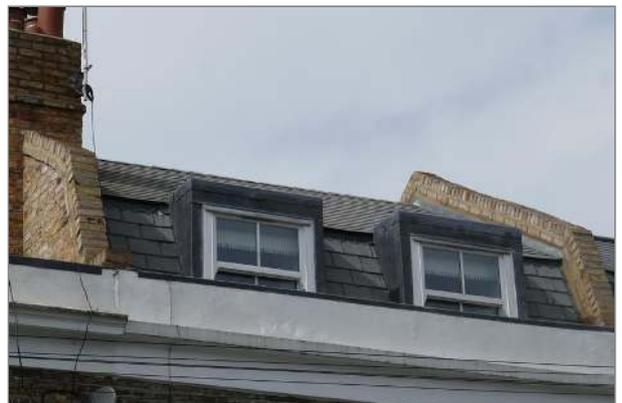
The roof slates appeared in a serviceable state of repair, with no significant defects noted. Box gutters also appeared in fair order, however, we cannot confirm the condition of the concealed surface pipe which connects the two, and we assume this is directed through the loft floor. Should this pipe leak then accessing it will likely be disruptive, possibly involving the need to open up the loft floor or the ceiling beneath. Condition Rating 1.

Photo - 7 Main roof slates in fair order.

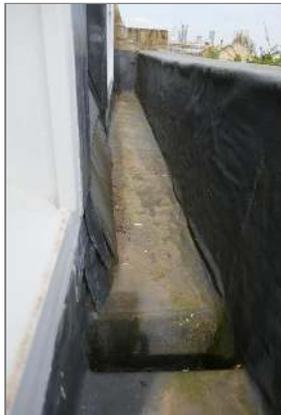
Photo - 8 The front box gutter, sloping into drainage outlet.

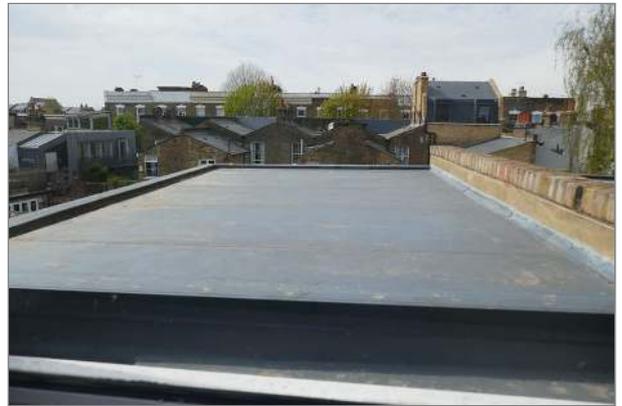
Photo - 9 The rear dormer covering; note drainage channel down left-side.

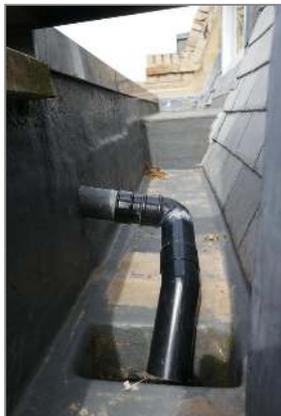
Photo - 10 The rear dormer drainage channel connecting into the rear box gutter.

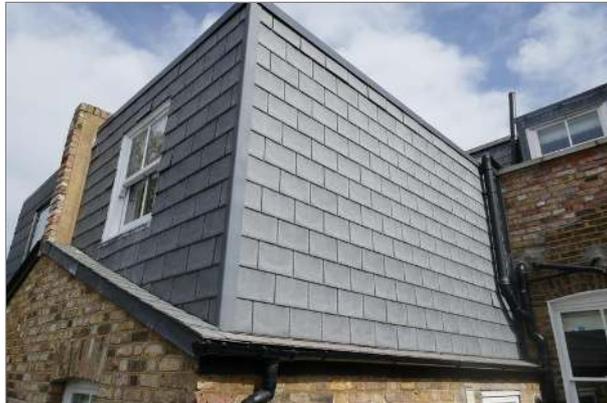
Photo - 11 Dormer wall slates in fair order.

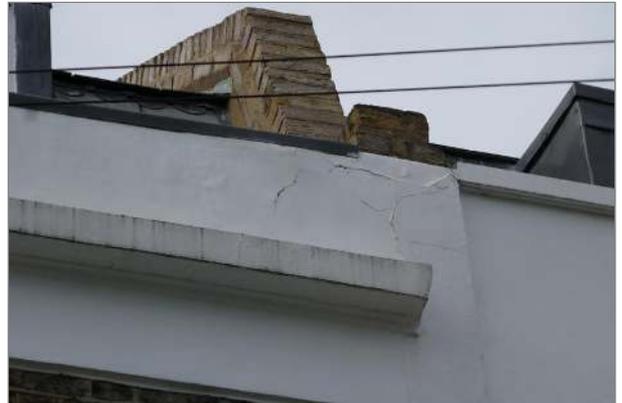
Brickwork and render were noted to be in satisfactory order, albeit there is some minor cracking in the render at the top of the front wall which will require making good as part of future maintenance. Render can be prone to cracking from time to time, and any cracks should be assessed for severity and subsequently made good to prevent water ingress. Condition Rating 2.

Photo - 12 Minor cracking in render at top of front wall.

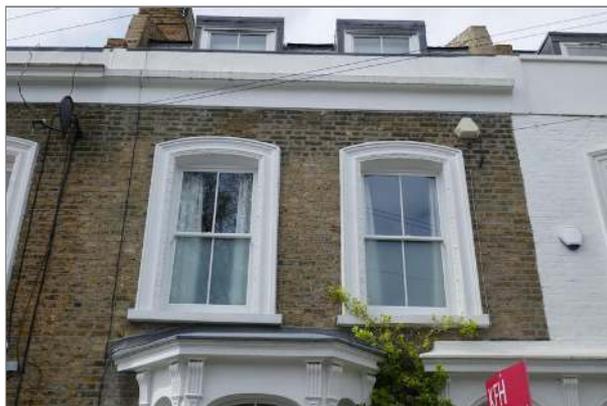
Photo - 13 Brickwork at front of property in fair order.

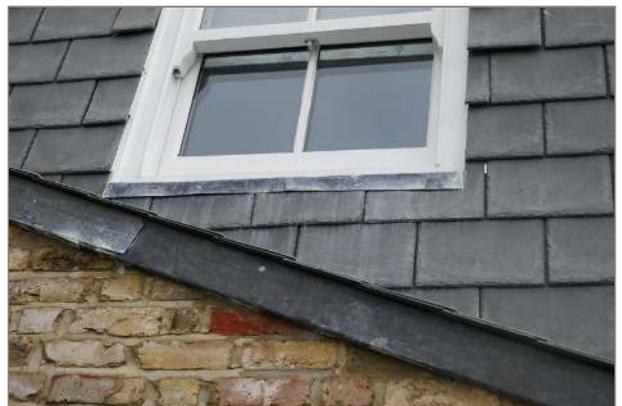
The brickwork was in reasonable condition, with only some minor weathering noted. The lead lashing to the back bedroom window sill has not been treated with patination oil, however, and

consequently, white-run marks can be seen here - albeit only minor and cosmetic in nature. Condition Rating 2.

Photo - 14 White run marks from back bedroom window sill flashing.

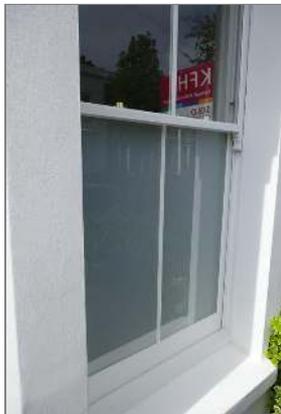
Photo - 15 Timber single glazed sash window in sound order.

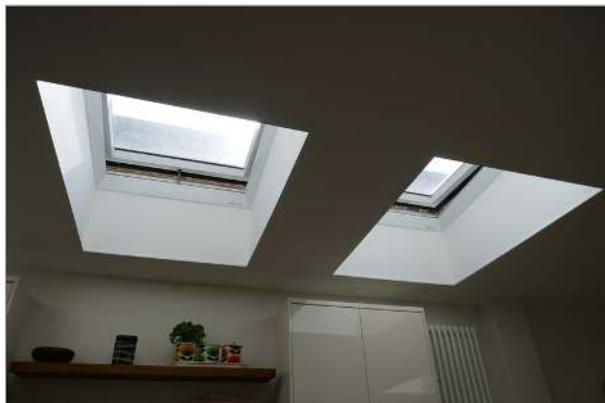
The kitchen roof lights functioned adequately at the time of inspection and you should ensure the vendor leaves the remote control with them. We have to advise, however, that we have not undertaken an assessment of the electrical components (see Sections F1 and I3). Condition Rating 3.

Photo - 17 The kitchen roof lights operated adequately.

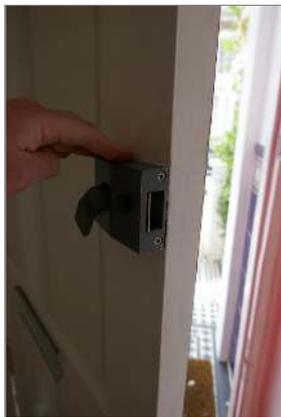
Photo - 18 Front door latch box is not BS:3621 rated.

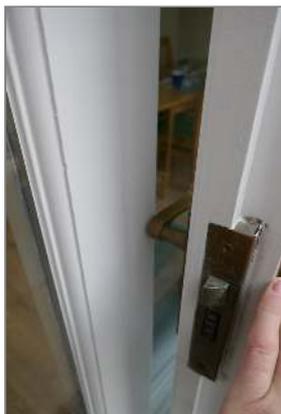
The doors were in reasonable condition, however, the back door' would benefit from fitting with a stop and can also be a little awkward to open from an external perspective once closed completely. The front door letter box is also loose. It is recommended waterproof seals are maintained between door frames and adjacent walls in order to minimise the risk of damp penetration. Condition Rating 1.

Photo - 20 Back door collides with adjacent frame due to lack of stop.

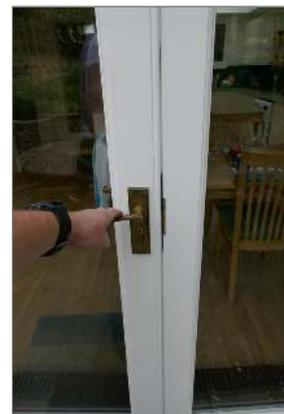
Photo - 21 Back doors pull together making the a little awkward to open from an external perspective.

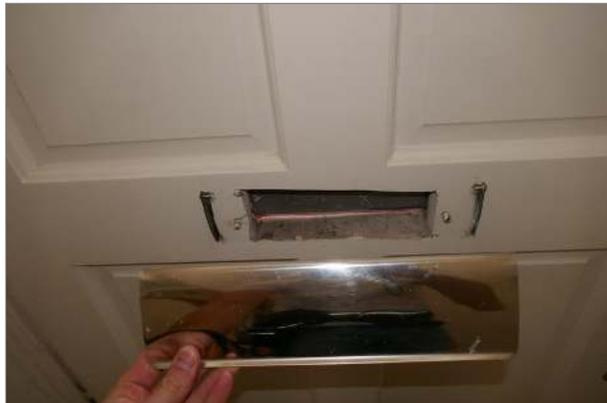
Photo - 22 The front door letter box is loose.

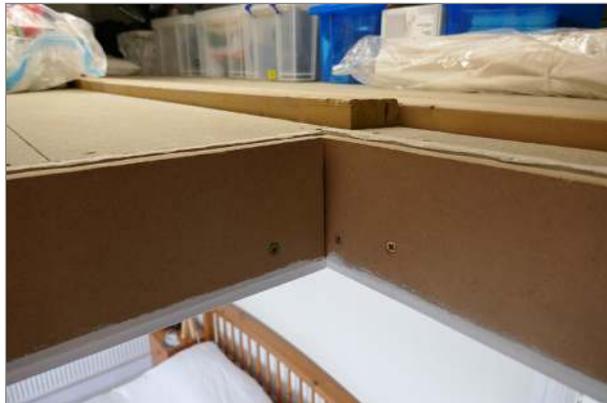
Photo - 24 Sectional thickness of loft floor could only allow for circa 100mm insulation.

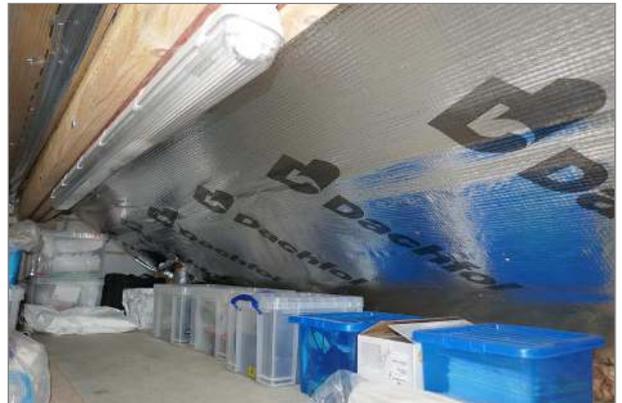
Photo - 25 Foil lining to underside of roof slopes appears to hold rigid insulation board behind.

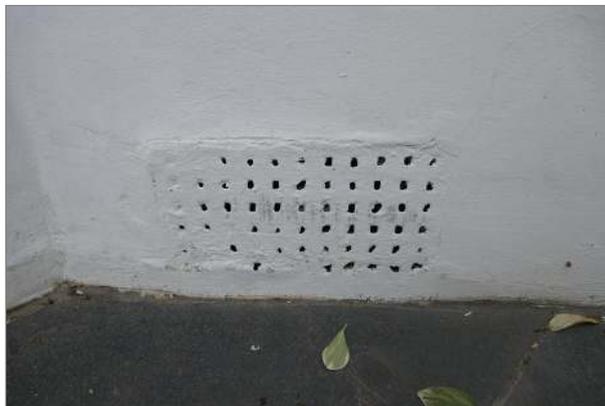
It is essential to maintain adequate ventilation beneath the timber ground floor to avoid moisture conditions which could lead to underfloor rot attack. This can be aided by ensuring sub-floor vents are left free of obstruction and are periodically cleared through. It is impossible to inspect these areas without taking the floors up, which is outside the scope of this report. Vents to the front are partially blocked with paint and should be cleared through with the likes of a narrow file. We cannot confirm how well ducted through the kitchen extension vents are to the original rear vents.

Photo - 29 Partially blocked front, sub-floor vent.

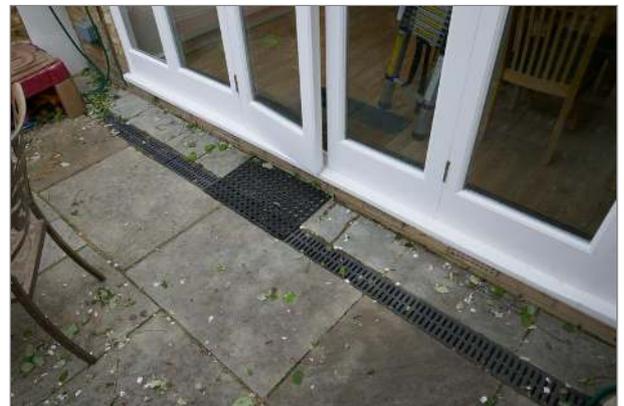
Photo - 30 Rear vents should be ducted to the original rear vents. Nice detail where a drainage channel is present before the vents.

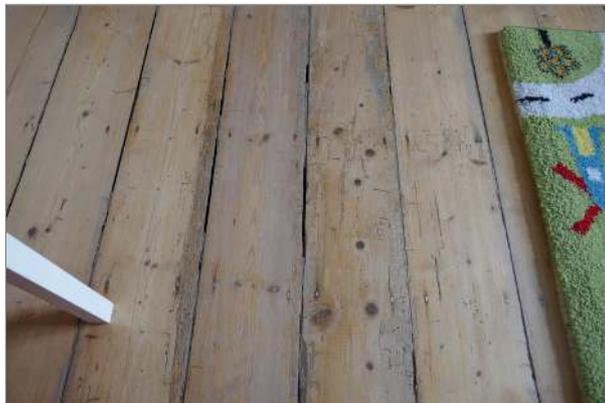
We noted indications of beetle infestation to exposed floorboards. The infestation appeared historic, however, it is possible areas concealed from view may be active (e.g. to the underside of floorboards). Your legal advisor to confirm whether any treatment works have been carried out and if these are backed with a meaningful guarantee (see Section H2). It would be prudent to appoint a reputable Property Care Association contractor to investigate further by way of lifting floorboards. Not inspected.

Photo - 31 Old beetle tracks to exposed floor boards.

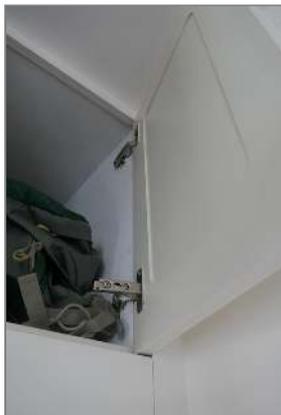
Built-in fittings are built into various rooms and are a mixture of styles and ages. They were in serviceable condition, however, we noted a loose hinge to a cupboard within the front, first-floor bedroom. Condition Rating 2.

Photo - 33 The loose front-bedroom cupboard hinge.

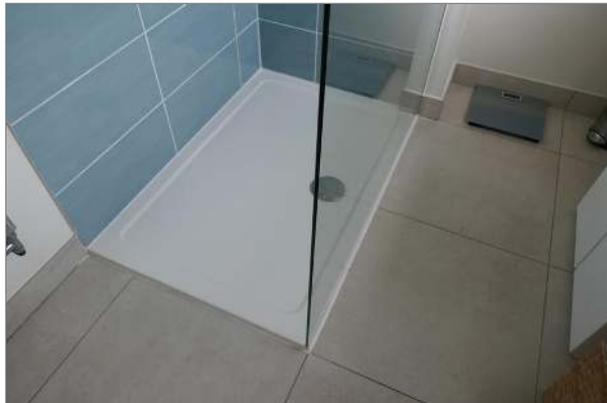
Photo - 36 Adequate sealant around shower tray.

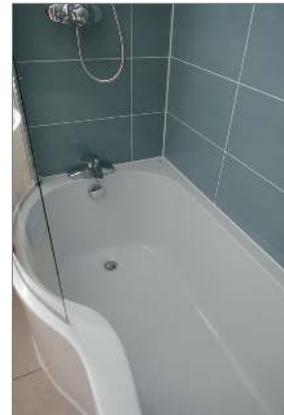
Photo - 37 Adequate sealant around bath.

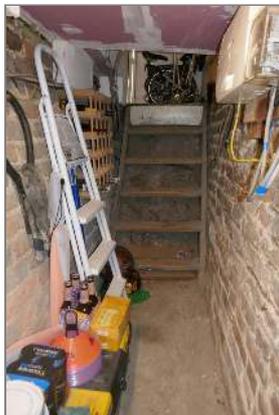
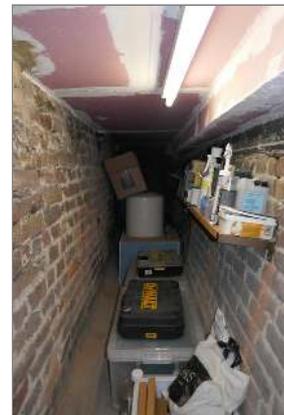
The cellar was in reasonable order. There is some minor dampness however this does not appear to be of real significance. Condition Rating 2.

Photo - 38 The cellar (1); some minor dampness, however, relatively dry by general standards.

Photo - 39 The cellar (2); some minor dampness, however, relatively dry by general standards.

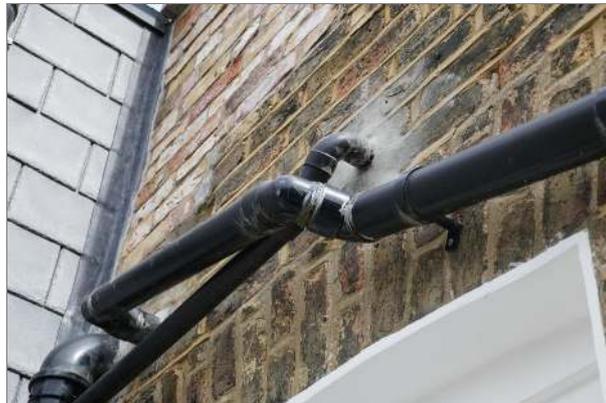
Where visible, above-ground drainage consists of uPVC construction. The general condition was satisfactory, however, there are some minor leaks from above ground drainage pipes at the rear of the building which need repair by a plumber. Condition Rating 2.

Photo - 45 Stain to waste pipe where leakage has been occurring.

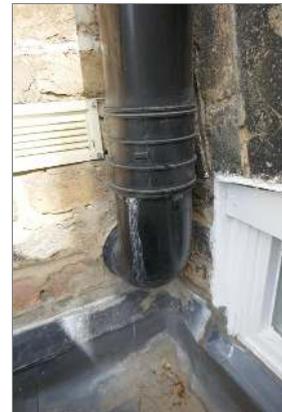
Photo - 46 White stain to soil pipe joint where slight leakage has occurred.

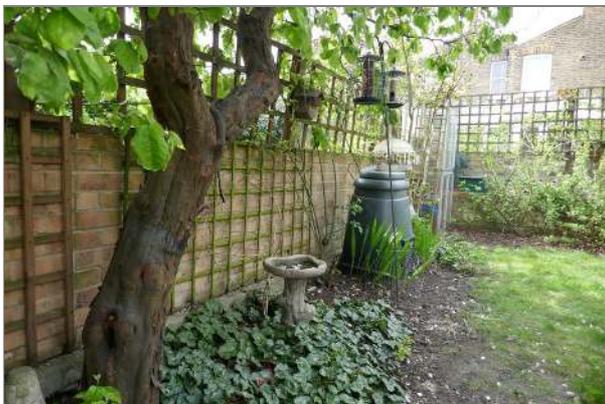
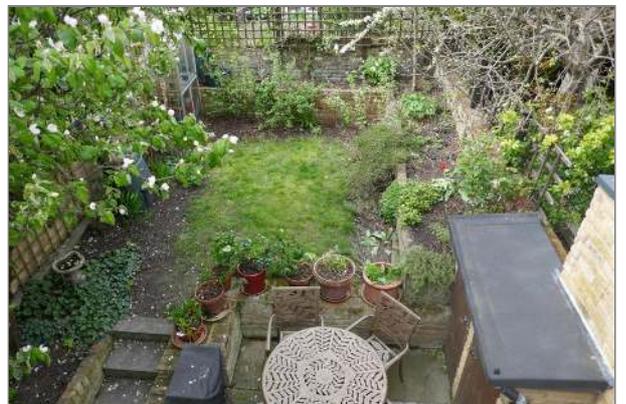
Photo - 47 The back garden in fair order (1).

Photo - 48 The back garden in fair order (2).

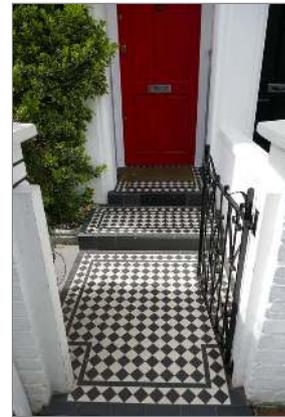
Photo - 50 The front pathway in sound order.
