LEVEL 2

Your survey report

17th November 2021

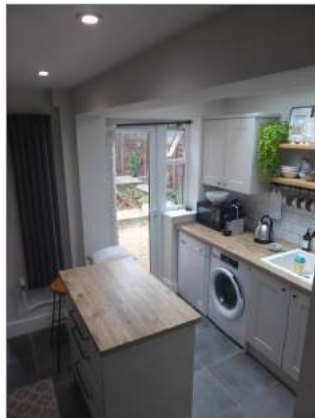
Photo - 10 Kitchen

The kitchen hob extractor unit must be switched on when washing up and cooking to reduce the build-up of condensation and fatty deposits.

No inspection has been made of built in appliances. If the condition of these is important to your purchase, then they must be fully serviced and tested by an appropriate engineer prior to legal commitment to purchase.

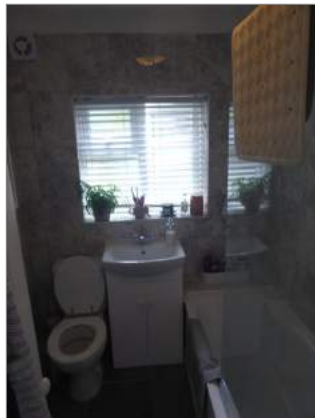
Photo - 11 Bathroom

The bathroom extractor fan was operational during the inspection and this must be switched on when using hot water appliances. There is no extractor in the en-suite WC.

Your legal advisor must confirm Building Control sign off was obtained for the installation of the en-suite WC (see Section H1).
